Suspended Road System on Peat: A Case Study in Sibü, Malaysia

*Jen Hua Ling, Huong Hun Ting, Yong Tat Lim, Wen Kam Leong and How Teck Sia

School of Engineering and Technology, University College of Technology Sarawak,
96000 Sibü, Sarawak, Malaysia

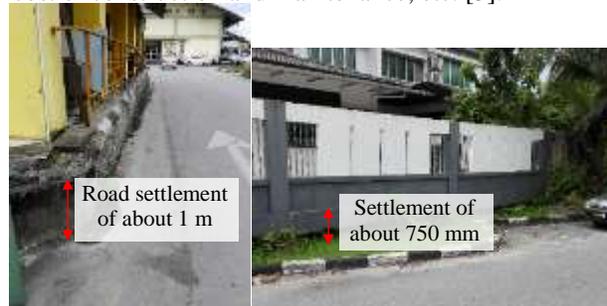
(a) Road settlement at a commercial lot (b) Post-construction settlement of a residential building

Figure 2: Settlement problem of peat in Sibü

Figure 2 shows the settlement problem of peat. The total settlement can surpass 300 mm within 1 year of construction and the differential settlements can exceed 1:150 [8]. This can cause instability and affect the service life of the structure building on peat. For that, peat is normally avoided for construction [5]. However, due to the increasing population, scarcity of land and necessity of economic growth, the infrastructure development on peatland is sometimes inevitable [9].

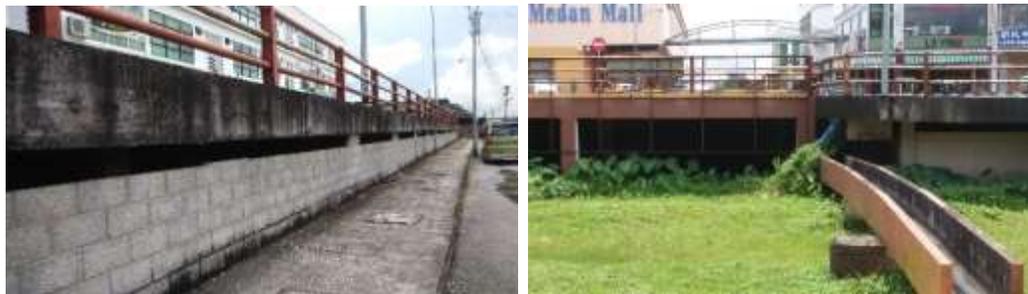
Figure 6: Public accessibility control underneath the platform

The SS system at Medan Mall was elevated from the peat surface for about 2 m. There was a large space between the ground and the platform levels, which was shaded, wet and overgrown with vegetation. It became a habitat of pests and wildlife like rats, snakes, lizards and mosquitoes, which may be a concern to the neighbourhood nearby.

To overcome the problem, concrete block walls were constructed as barriers along the pedestrian paths to prevent the accessibility of the public and to isolate the wildlife habitat from the community (Figure 6). As for the inaccessible areas, no barrier was provided. Thus far, there was no reported case on the hazards of health and safety associated with it.

(a) Concrete block wall along pedestrian path

(b) No wall at inaccessible places

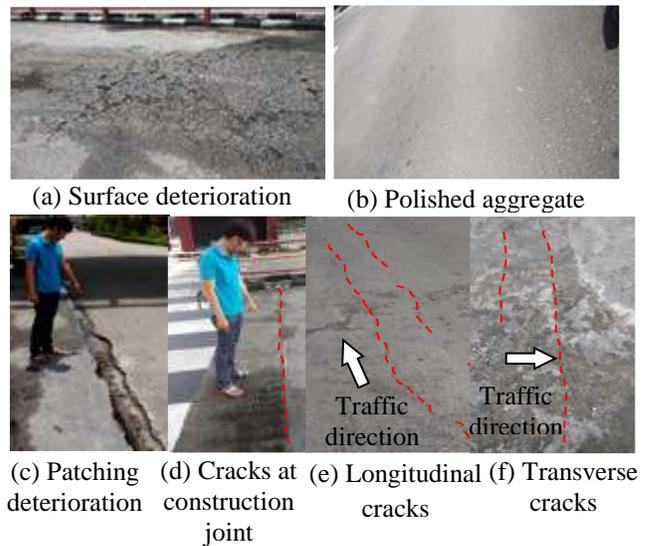
Figure 7: Distresses on rigid pavement at Medan Mall

The distresses found on the rigid pavement at Medan Mall included surface deterioration, patching deterioration, polished aggregate, longitudinal cracks and transverse cracks (Figure 7) at low to medium levels of severities (Table 2). The distresses were mainly caused by (a) repeated abrasions by traffic, (b) expansion and shrinkage movement due to daily thermal cycle, (c) progressive deterioration by traffic loads and (d) poor bond between the construction joints.

Distress	Severity level ^{*1}			
	N	L	M	H
Blowup/ Buckling	√			
Corner break	√			
Divided slab	√			
Faulting	√			
Joint seal damage	√			
Lane/ shoulder drop-off	√			
Patching deterioration			√	
Polished aggregate ^{*2}			√	
Popouts ^{*2}	√			
Punchout	√			
Scaling, map cracking, crazing	√			
Shrinkage cracks ^{*2}	√			
Spalling corner	√			
Spalling joint	√			
Transverse cracks		√		
Longitudinal Cracks		√		
Surface Deterioration			√	
Shattered Slab	√

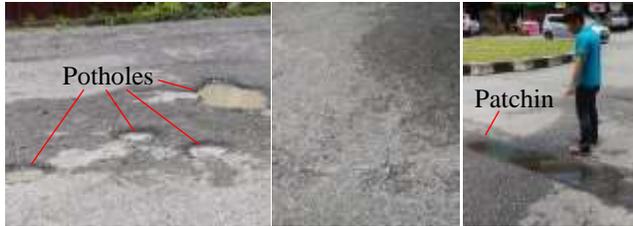
The distresses found on the flexible pavement at Jalan Chew Sik Hiong were potholes, ravelling and patching (Figure 8) at moderate severity (Table 3). The

distresses were mainly due to (a) repeated abrasions by traffic, (b) progressive deterioration by traffic loads, (c) seepage of water and (d) poor binding of asphalt pavement.

(a) Potholes (b) Ravelling (c) Patching
Figure 8: Distresses on flexible pavement at Jalan Chew Sik Hiong

For laying the services under the pavement, numerous places of the flexible pavement had been cut and patched. This directly affected the durability and ride quality of the pavement. For the uneven surface level and inhomogeneity of the patching with the existing pavement, stress tended to concentrate at the joint, and

this caused the patching area to deteriorate rapidly. Maintenance would be required from time to time.
